**HOUSATONIC RIVER BASIN
SEYMOUR, CONNECTICUT**

**MIDDLE RESERVOIR DAM
CT 00590**

**PHASE 1 INSPECTION REPORT
NATIONAL DAM INSPECTION PROGRAM**

APRIL, 1980

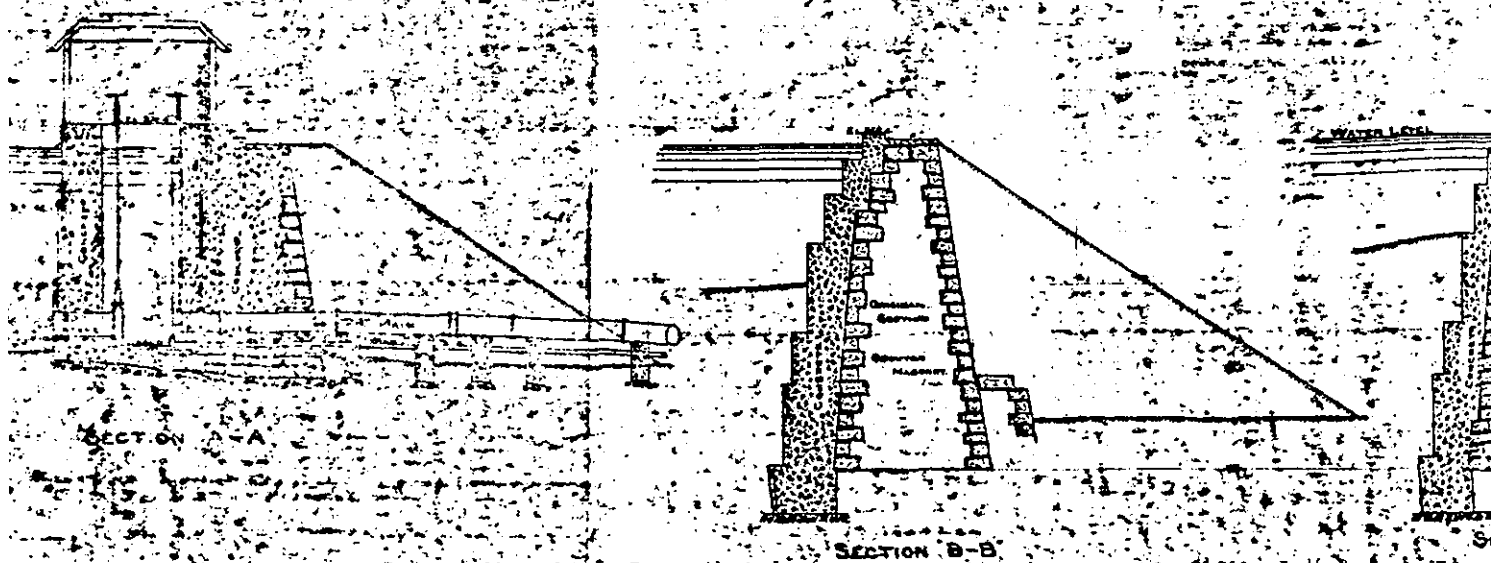
THE ANSONIA WATER CO.
IMPROVEMENT OF DAM AT MIDDLE RESERVOIR

limit leakage. Subsequent to the 1905 improvements, the east crest of the dam has been raised approximately 1.5 feet by the addition of a masonry and concrete wall, and the auxiliary spillway constructed. A crest rehabilitation program was undertaken in about 1975, including mechanical removal of spalled concrete, but was not completed leaving the crest in a severely spalled condition.

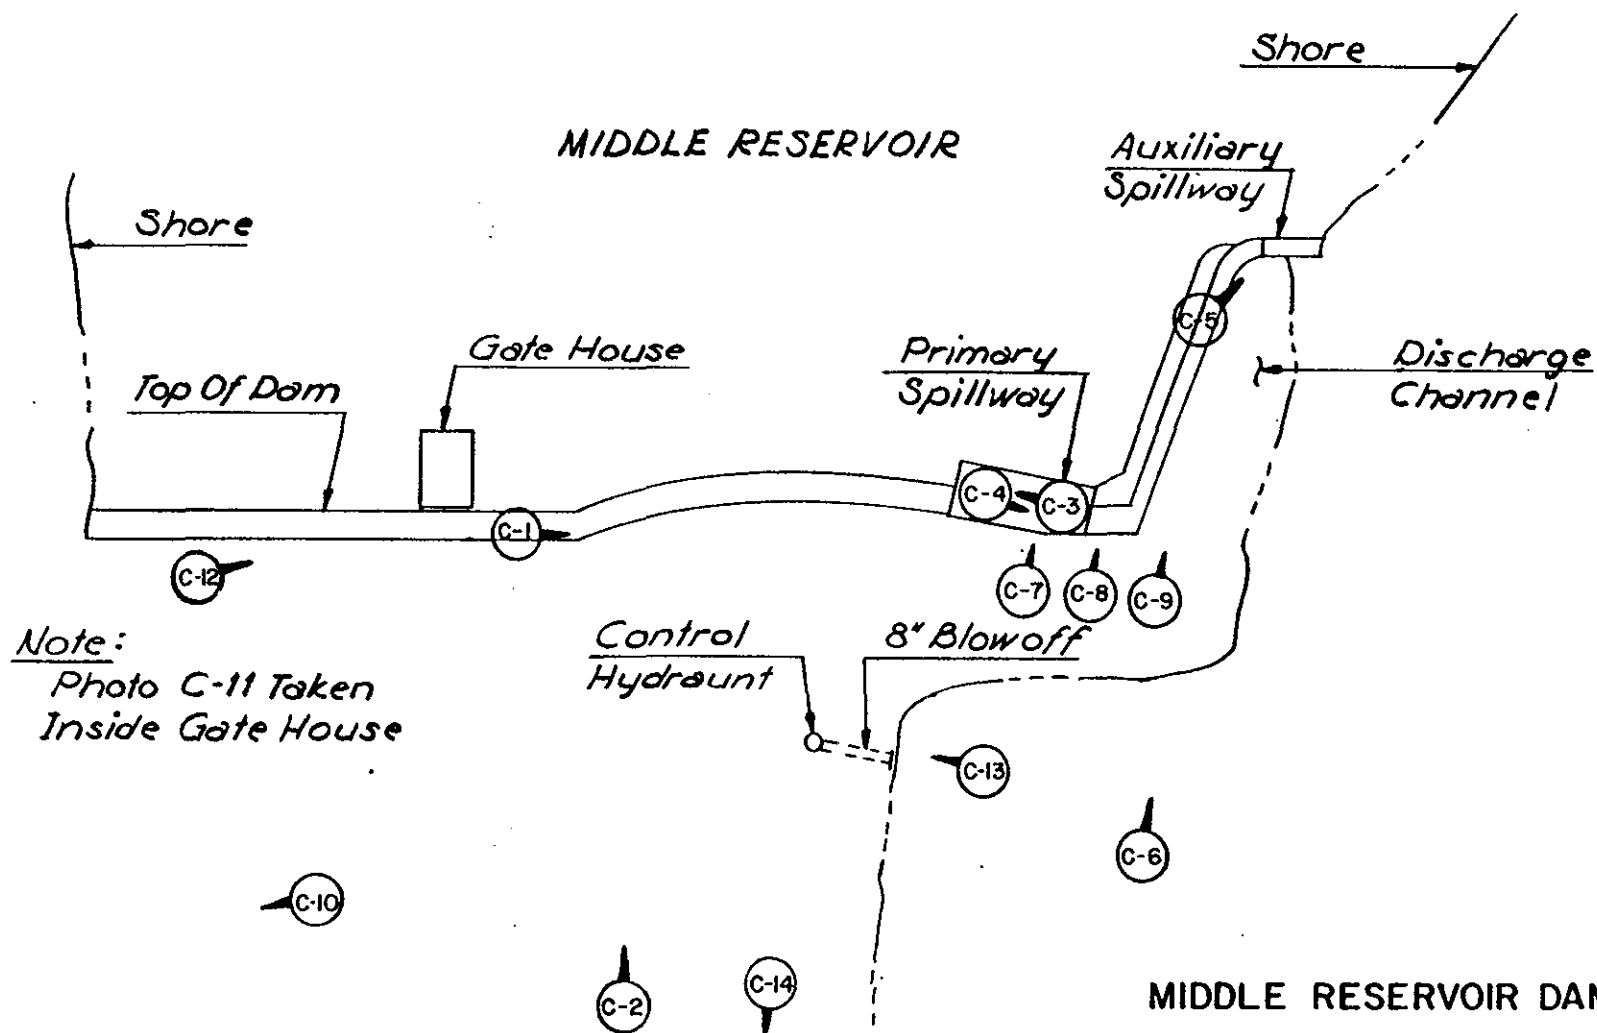
MIDDLE RESERVOIR DAM
PHOTO INDEX

Note:
Photo C-11 Taken
Inside Gate House
